FORD:
2005 Mustang

TSB 05-17-14 (Continued)

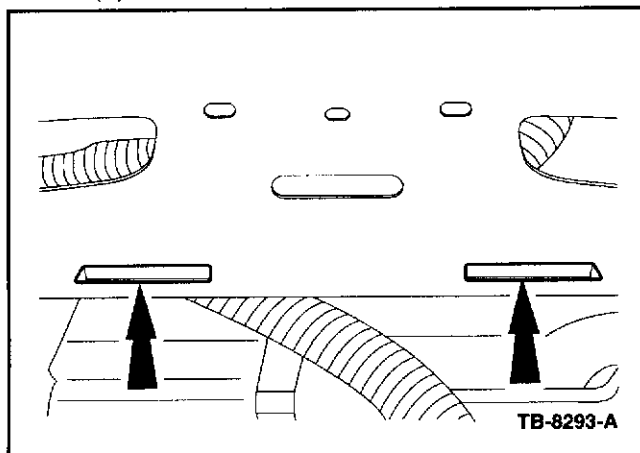
Figure 1 - Article 05-17-14

Some 2005 Mustang vehicles may exhibit the seat cushion cover front trim being loose on the front seat. The J-clip that holds the seat cushion cover trim to the front of the seat pan may not be fully engaging the flanges (slots) in the seat pan.

FIGURES 1 AND 2 ONLY SHOW TWO (2) OF THE SEAT PAN FLANGES (SLOTS), THERE ARE FOUR (4) IN TOTAL.

1. Remove the affected seat. Refer to Workshop Manual Section 501-10.
2. Pull back the seat cushion cover trim and foam to access the (4) flanges in the seat pan (Figure 1).
