ISSUE

The Sync Accessory Protocol Interface Module (APIM) may require updates to add system enhancements, improve system reliability or address consumer issues. The installation or availability of these updates may be made available in two different methods:

SERVICE TIPS

TSB 08-21-2 (Continued)

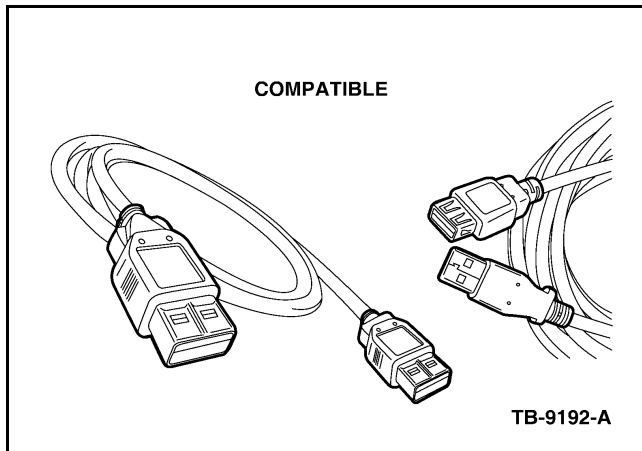
Figure 1 - Article 08-21-2

1. Turn the ignition key to the On position.
2. Turn the audio control module (ACM) on.
3. Connect the scan tool to the data link connector (DLC).
4. Connect one end of the USB male-A to male-A cable Rotunda part number CCMUSB2-AM-AM-10 (1-800-Rotunda option 6) or equivalent to the scan tool. Compatible cables. (Figures 1) Non-compatible cables. (Figure 2)
