Printable View (39512 KB)	
TSB 09-12-12	<ul style="list-style-type: none"> • 5R55S/5R55N/5R55W TRANSMISSIONS - SHIFT CONCERNS, LOSS OF 2ND, 3RD AND 5TH GEAR, INCORRECT RATIO DTC'S - PROCEDURE TO INSPECT AND REPAIR SERVO PIN BORE WEAR
Publication Date: June 11, 2009

FORD:	2002-2005 Thunderbird 2005-2009 Mustang 2002-2009 Explorer 2007-2009 Explorer Sport Trac
LINCOLN:	2002-2006 Lincoln LS 2003-2005 Aviator
MERCURY:	2002-2009 Mountaineer

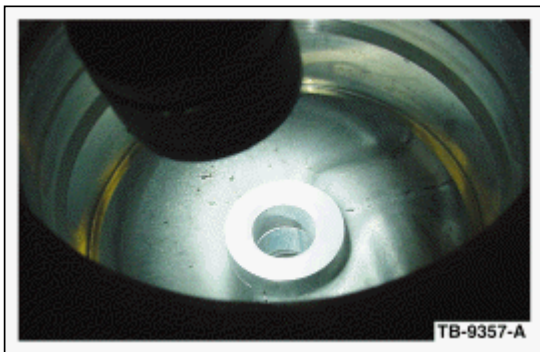
Figure 1 - Article 09-12-12

For transmissions that have been determined to require an overhaul or rebuild and the overdrive band or intermediate band have excessive wear or burned/damaged band friction material, the cause maybe excessive servo pin case bore wear generally found on higher mileage vehicles, usually accompanied with incorrect ratio diagnostic trouble codes (DTCs), condition becomes worse when hot. (Figure 1)

In our instructions, when we refer to the overdrive bore, we are talking about the smaller bore located closest to the bell housing. When we refer to the intermediate bore, we are talking about the larger bore located next to the line pressure tap.
